REPORT ON LEVEE FAILURES AND DISTRESS
SAN JACINTO RIVER LEVEE AND BAUTISTA CREEK CHANNEL,
RIVERSIDE COUNTY, SANTA ANA RIVER BASIN, CALIFORNIA

August 1980

Prepared for
U. S. Army Engineer District, Los Angeles
Los Angeles, California

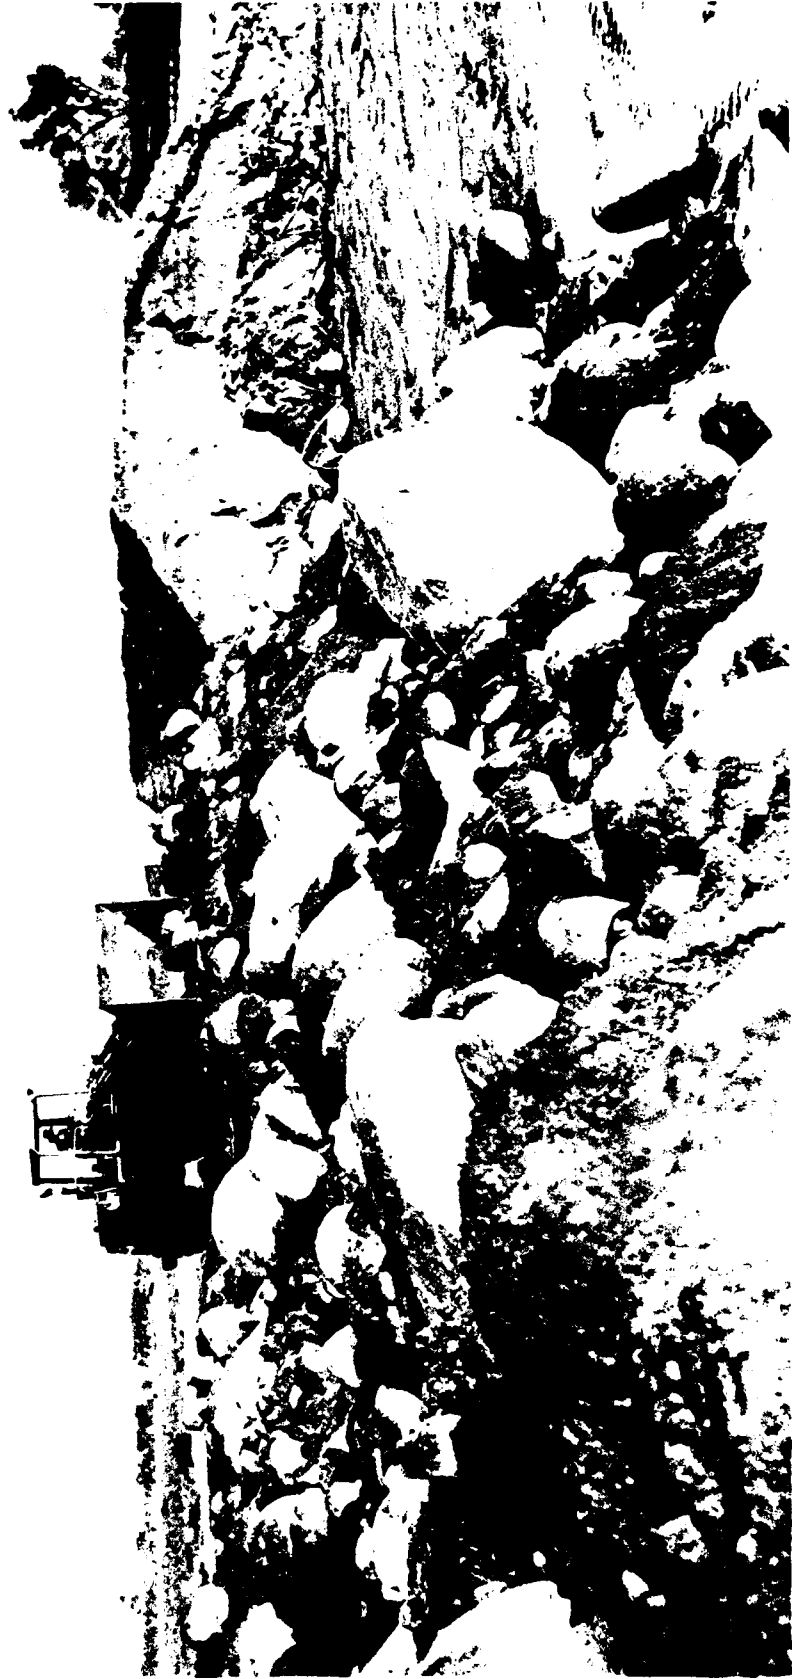
Figure No. 7

San Jacinto River Levee Breach (Bautista Creek)

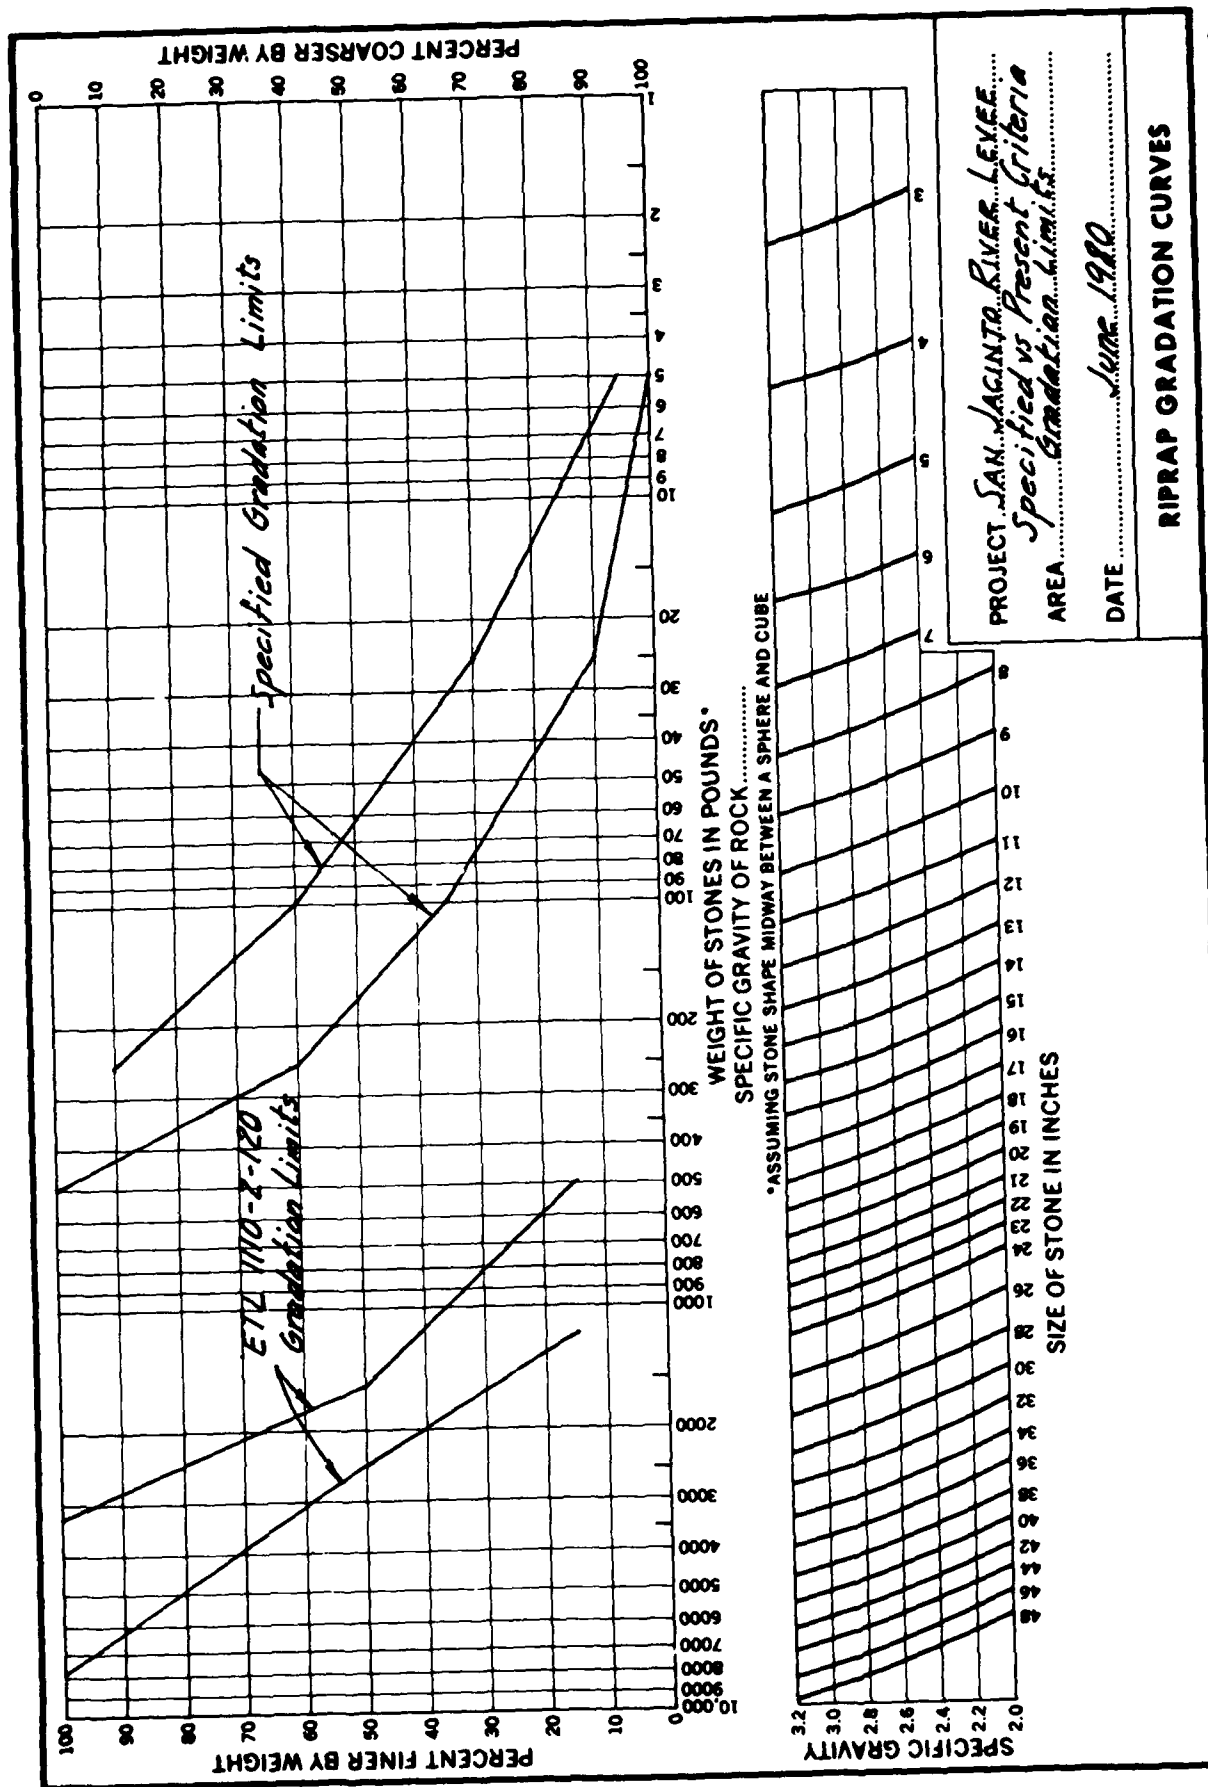
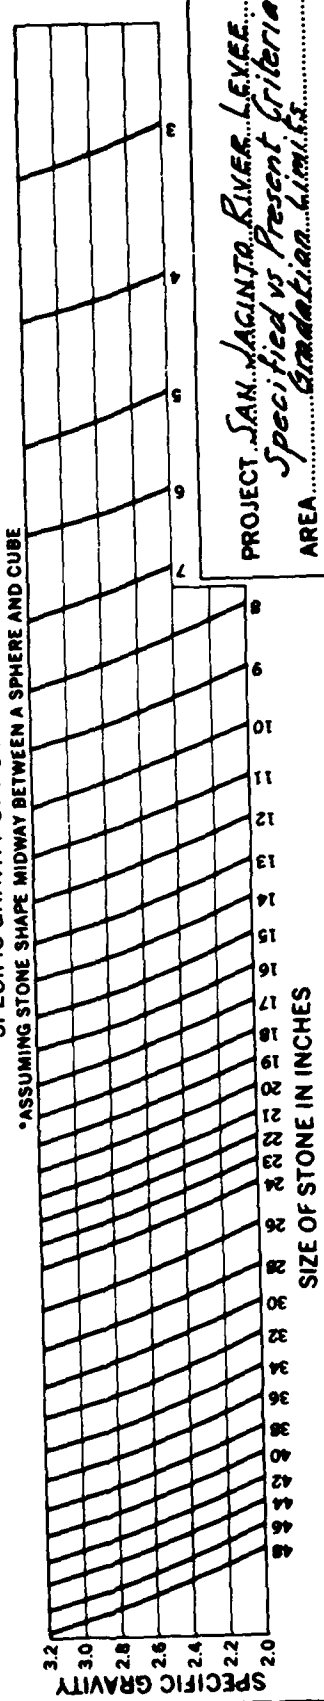
Figure 8

Based on present criteria (ETL 1110-2-120), a significantly thicker layer of heavier stone would be required to withstand flood velocities (Figure 8). Although no evidence was found that surface erosion was a significant factor in levee failure, the undersized riprap protection compared with present criteria would probably be subject to failure by surface erosion during larger floods up to design flood magnitude.
